Riverbend Riverbank Water District

2025 RRWD Reservoir Maintenance – Midco Diving & Marine Services – July 26, 2025

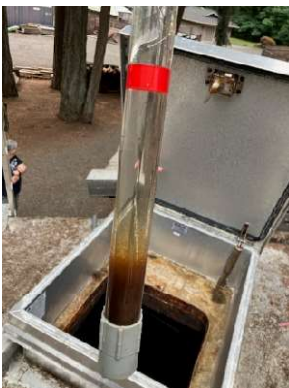
fig.1

8:15 am – Bob measured sediment level at 4” (fig.1)

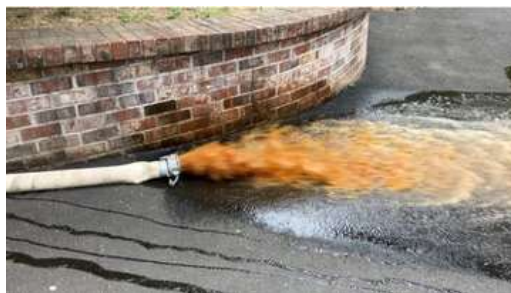
fig.2

10:39 am – Midco pumping out at rate of 10” in 30 minutes (fig.2, fig.3)

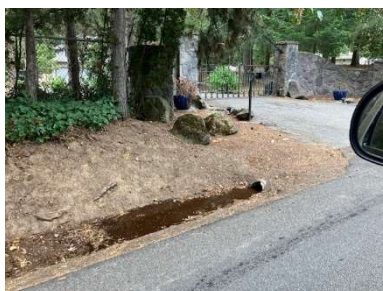
fig.4

11:34 am – Culvert moving through ok (fig.4), Culvert semi plugged (fig.5)
