**Confidential Report of Procedures and Findings  
From the Cleaning & Inspection of the  
Primary Tank  
Riverbend-Riverbank Water District  
West Linn, OR**

**RE: 2025 Tank Maintenance Project**

The following is a summary of a visual and video inspection of the Primary Tank for Riverbend-Riverbank Water District in West Linn, OR. This inspection was undertaken on July 26, 2025 by Midco Diving & Marine Services, Inc., of Rapid City, SD. The findings of this inspection report are a supplement to the inspection video.

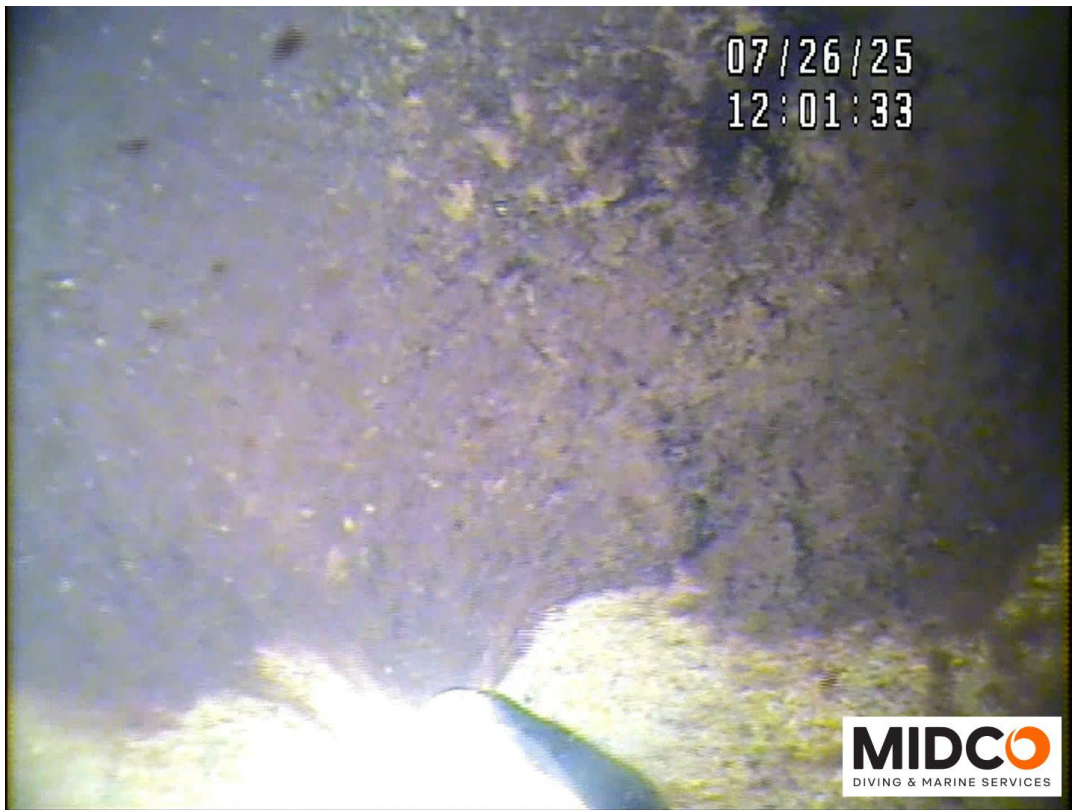
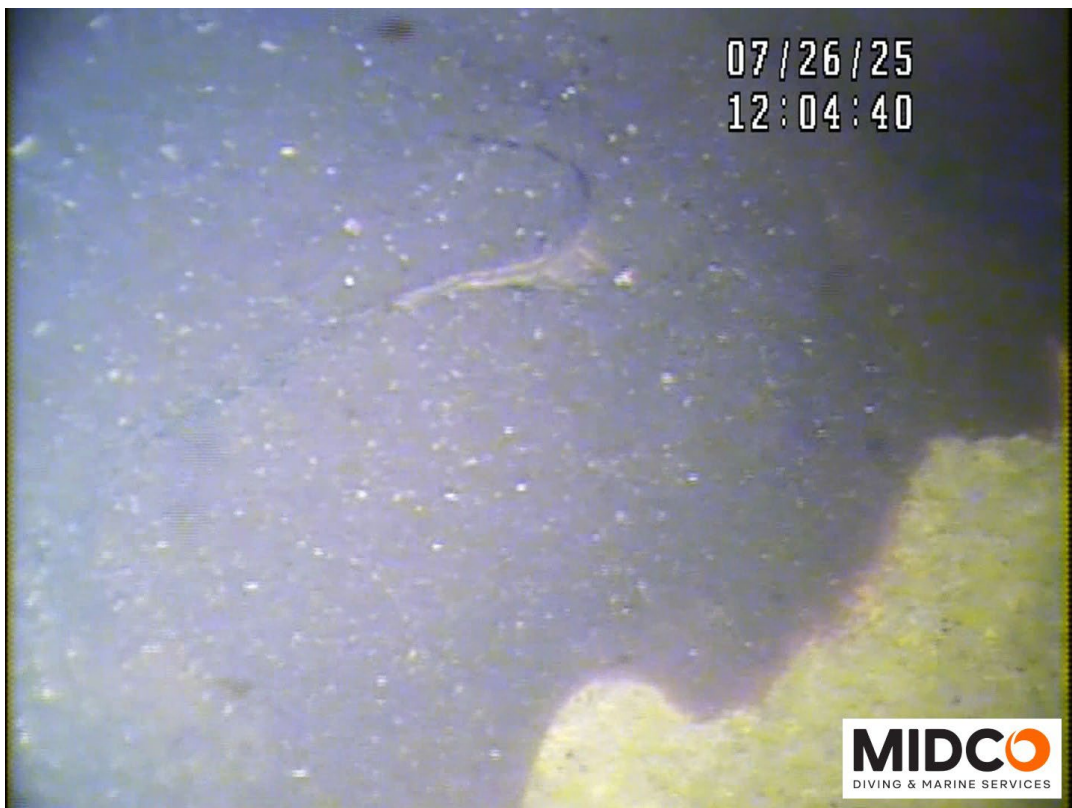
**Cleaning Reservoir – Up to 10" of Sediment Noted**

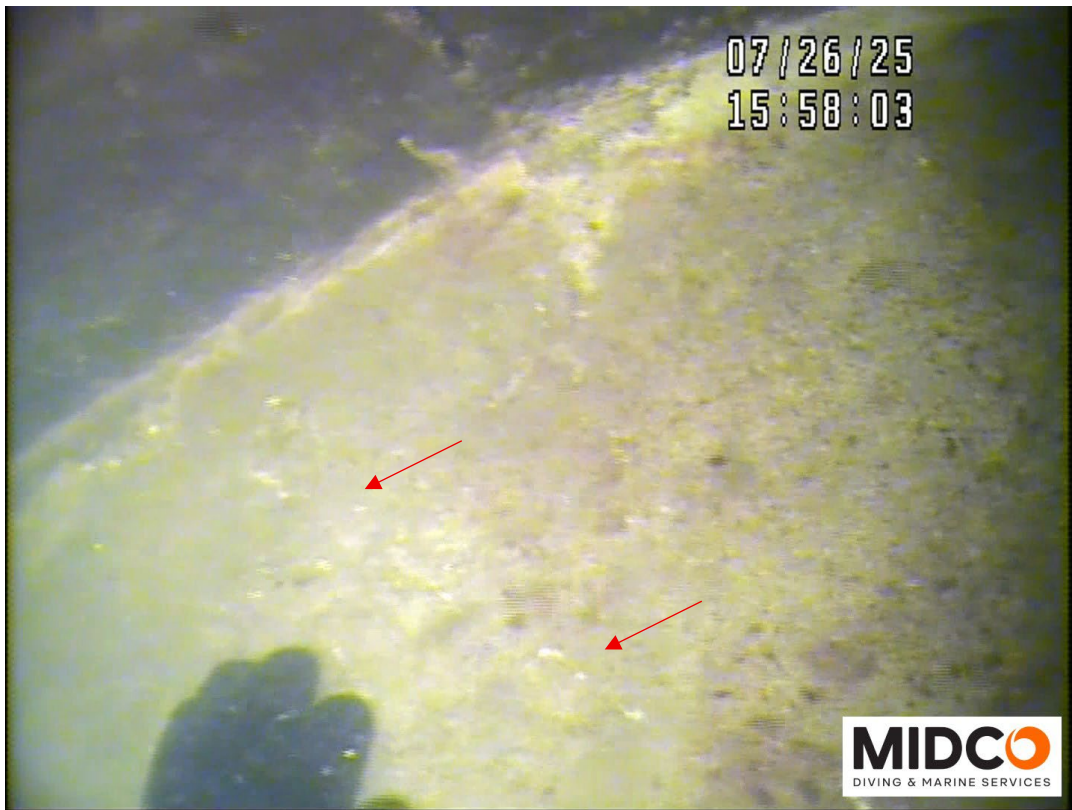
**Typical Floor – Settling Cracks with Efflorescence Noted**

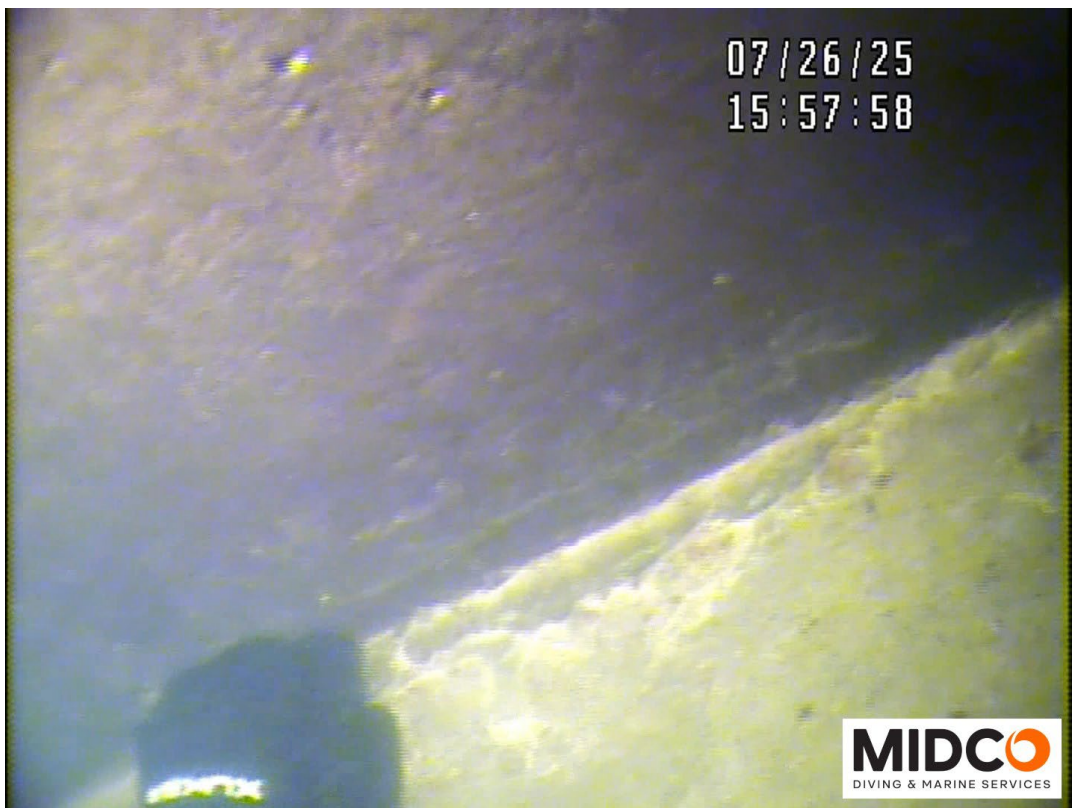
**Floor to Wall Seam – Settling Cracks & Spalling Noted**

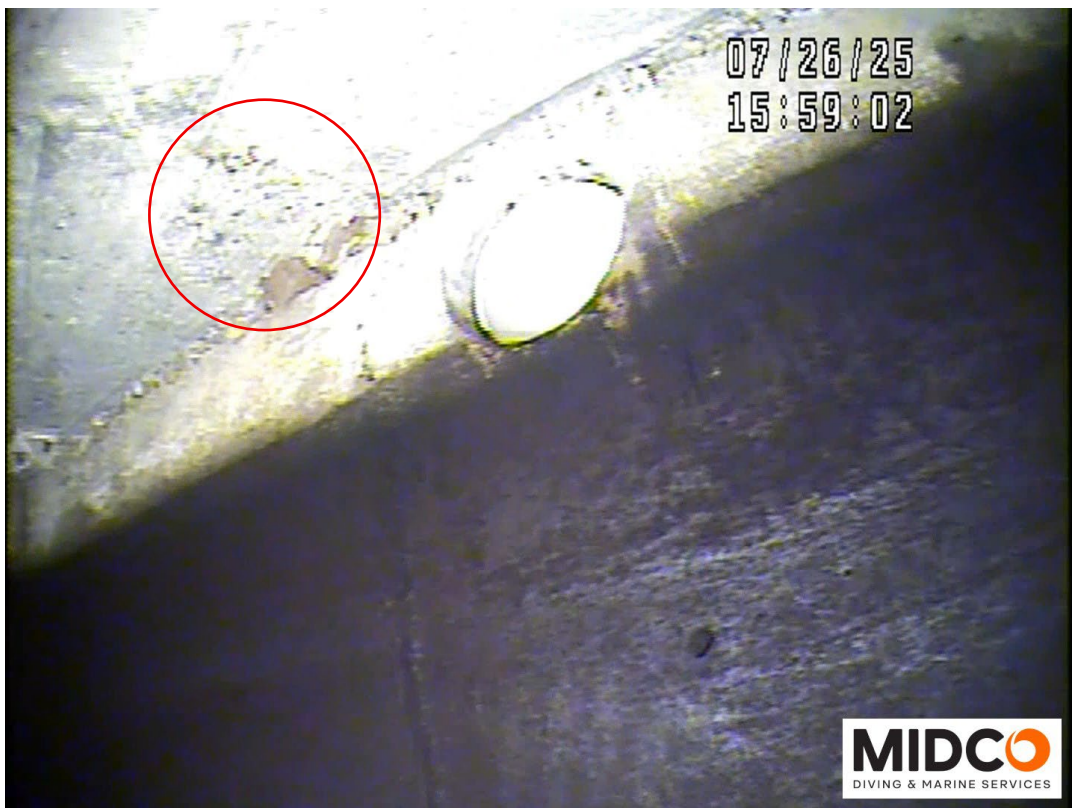
**Overflow Plumbing & Wall to Roof Seam – Spalling Noted**

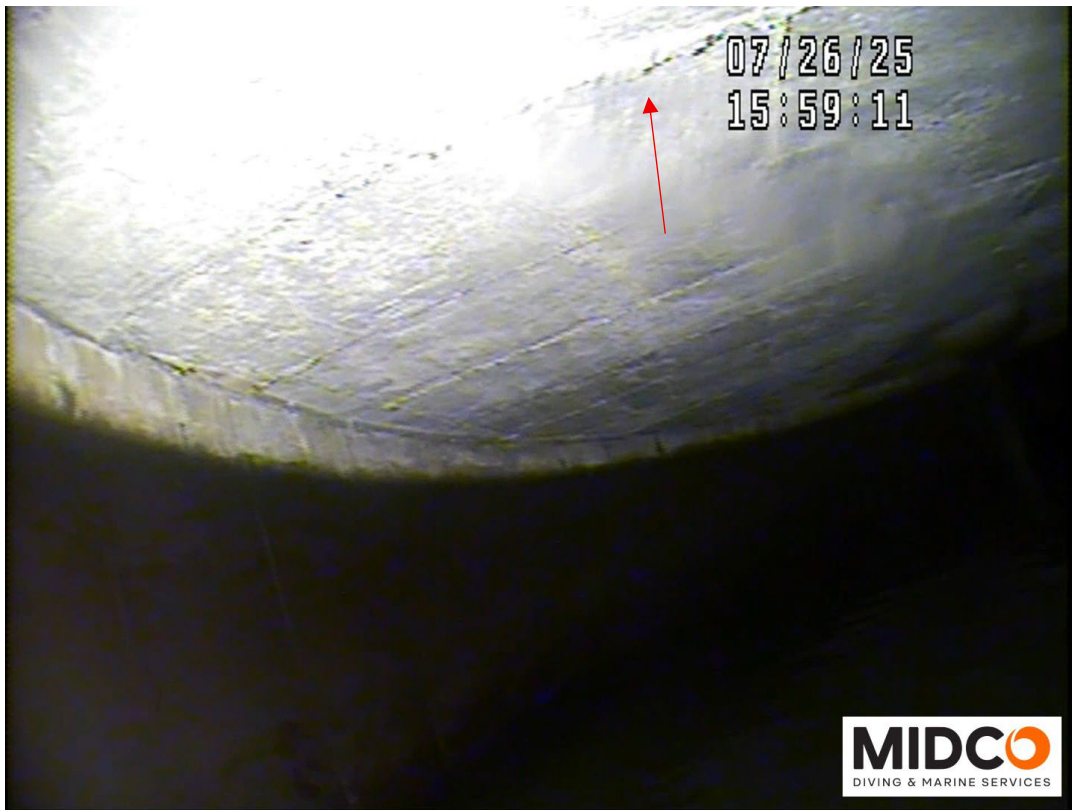
**Wall to Roof Seam – Settling Cracks & Spalling Noted**

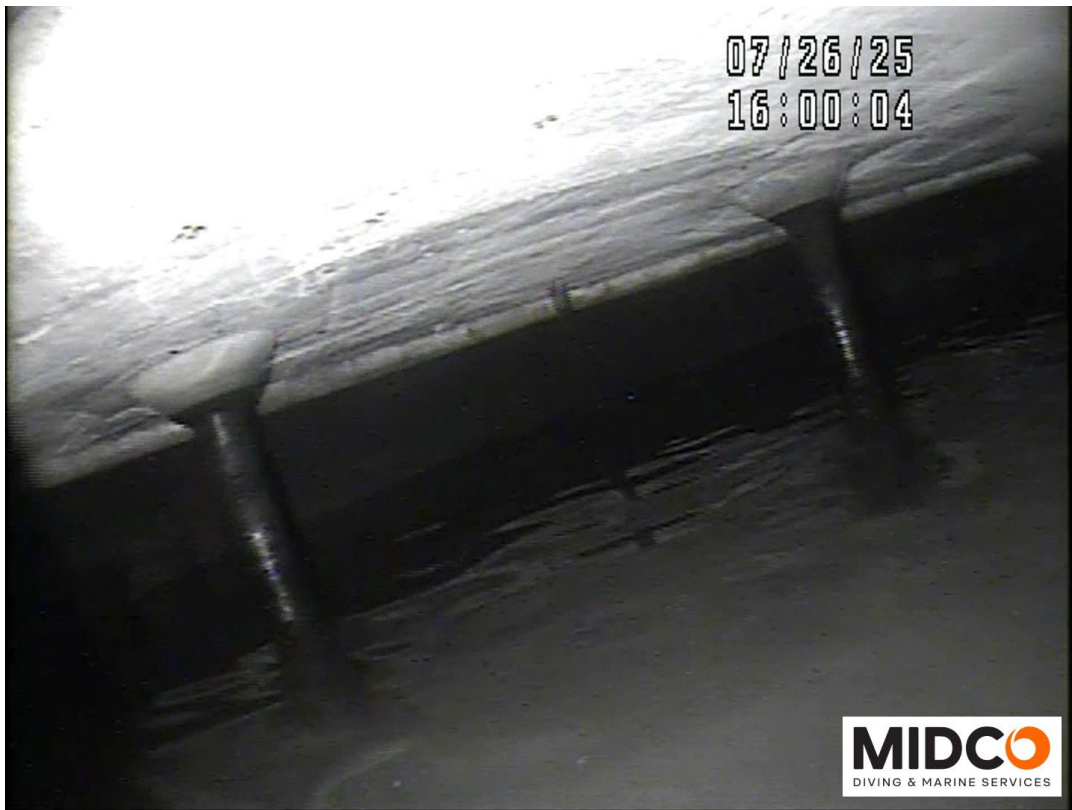
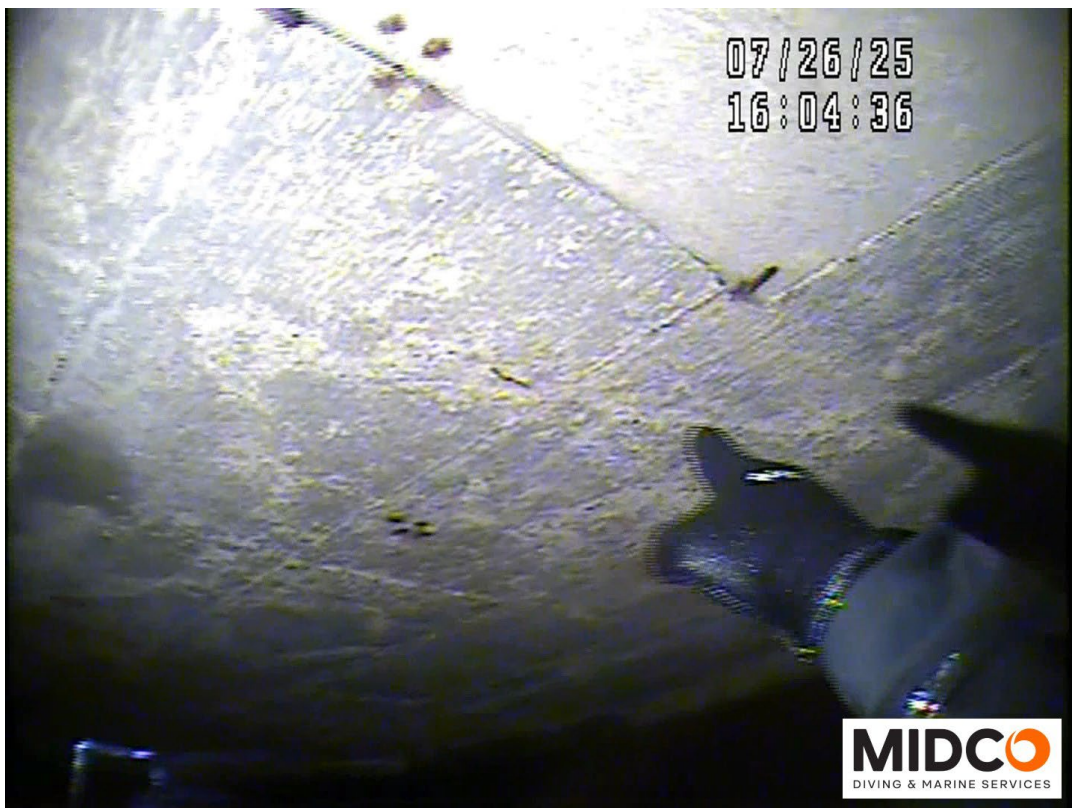
**Typical Roof – Exposed Rebar with Corrosion Noted**

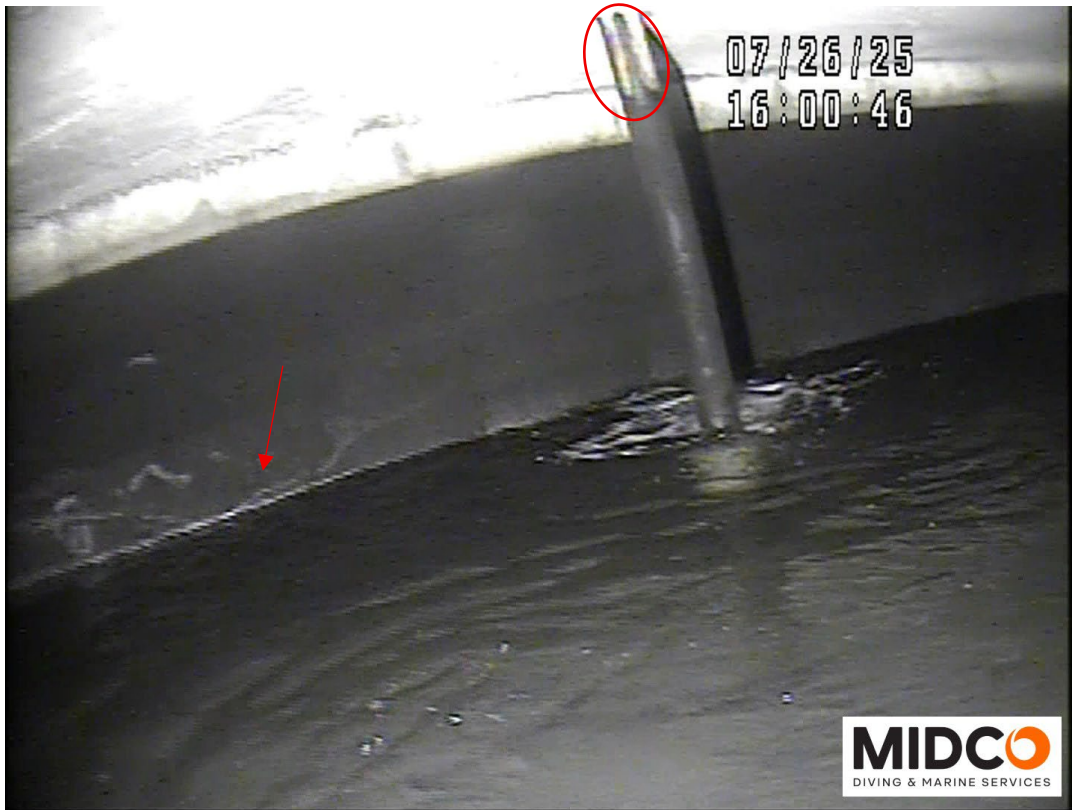
**Inlet Plumbing – Corrosion & Settling Cracks Noted**

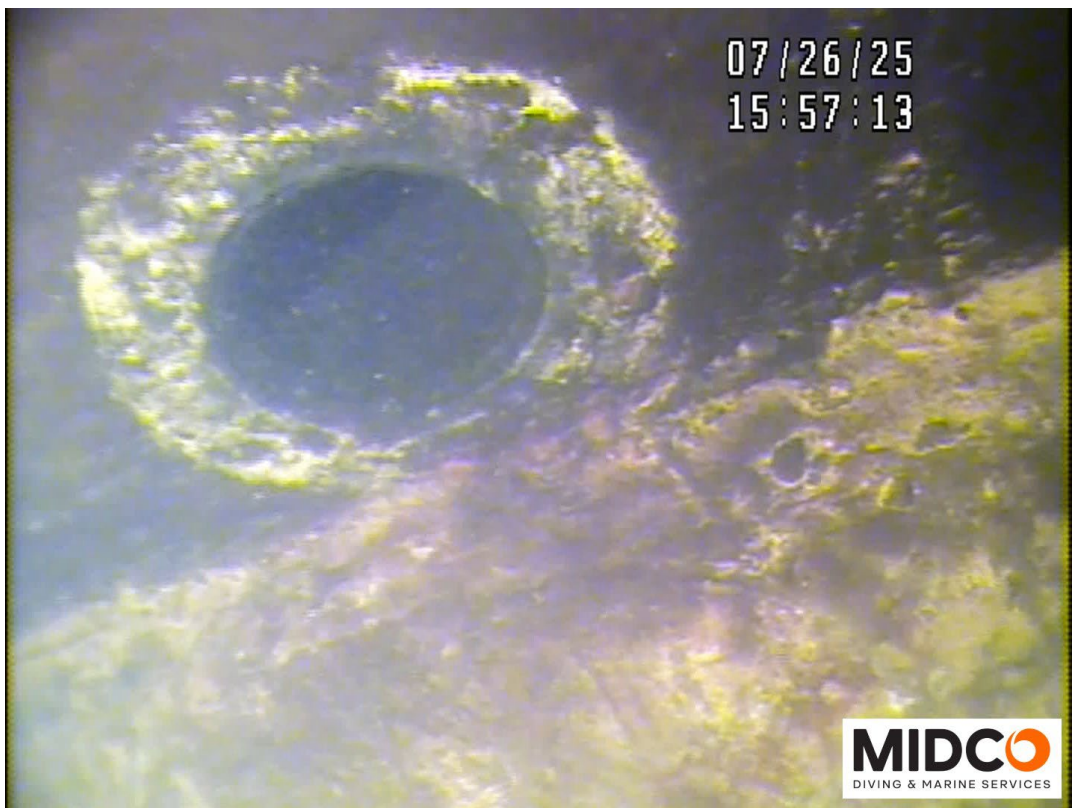
**Outlet Plumbing – Spalling Noted**

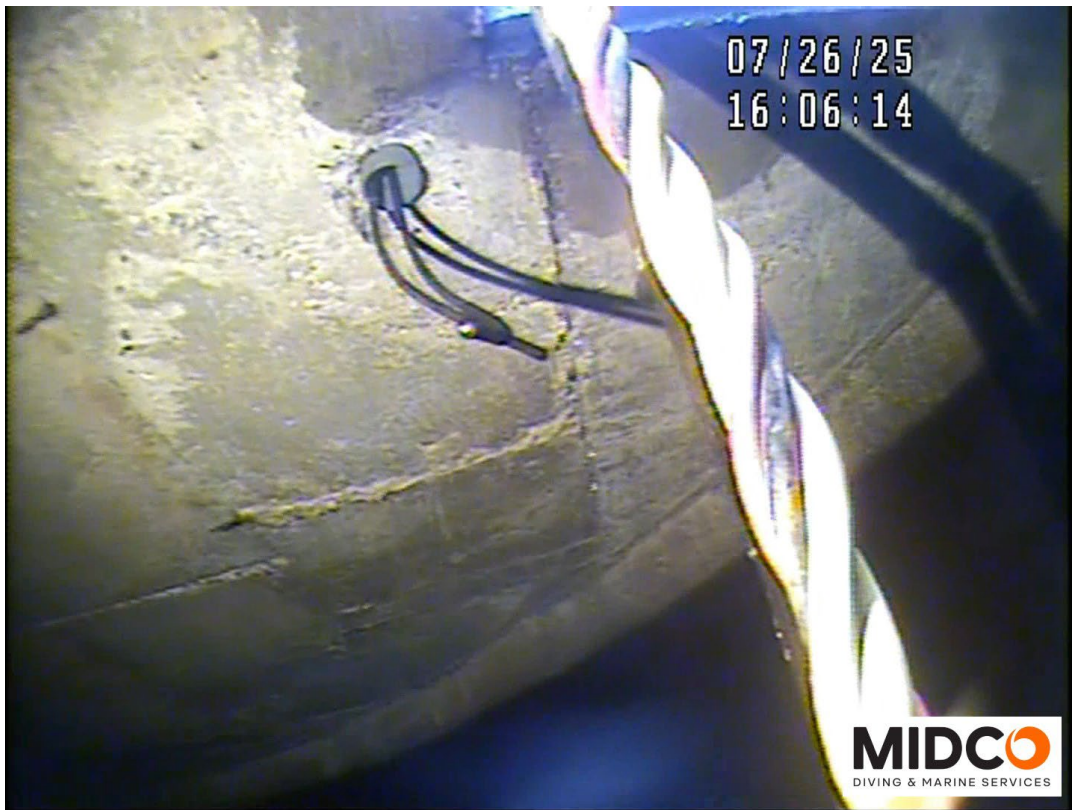
**Interior Telemetry – Not Functioning**

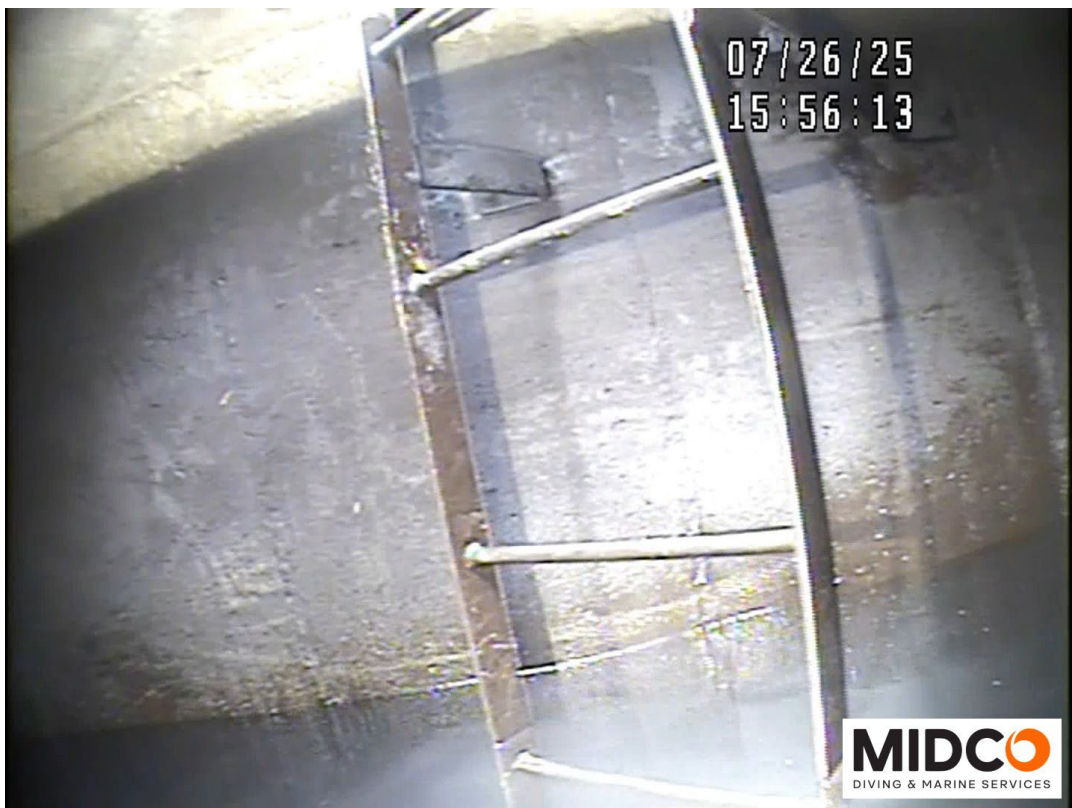
**Interior Ladder – Corrosion Noted**

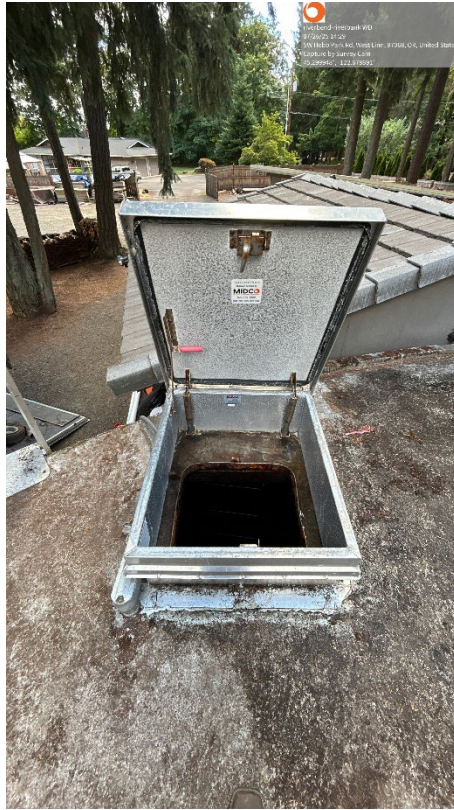
**Access Hatch – Weather Stripping Deterioration Noted**

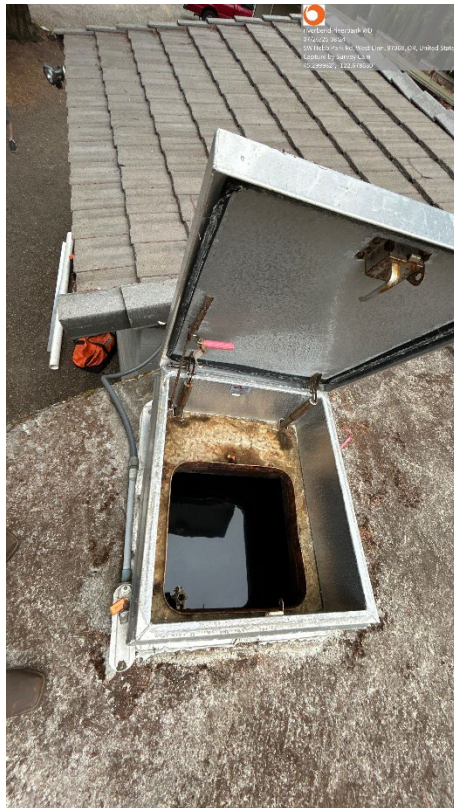
**Access Hatch – Corrosion Noted**

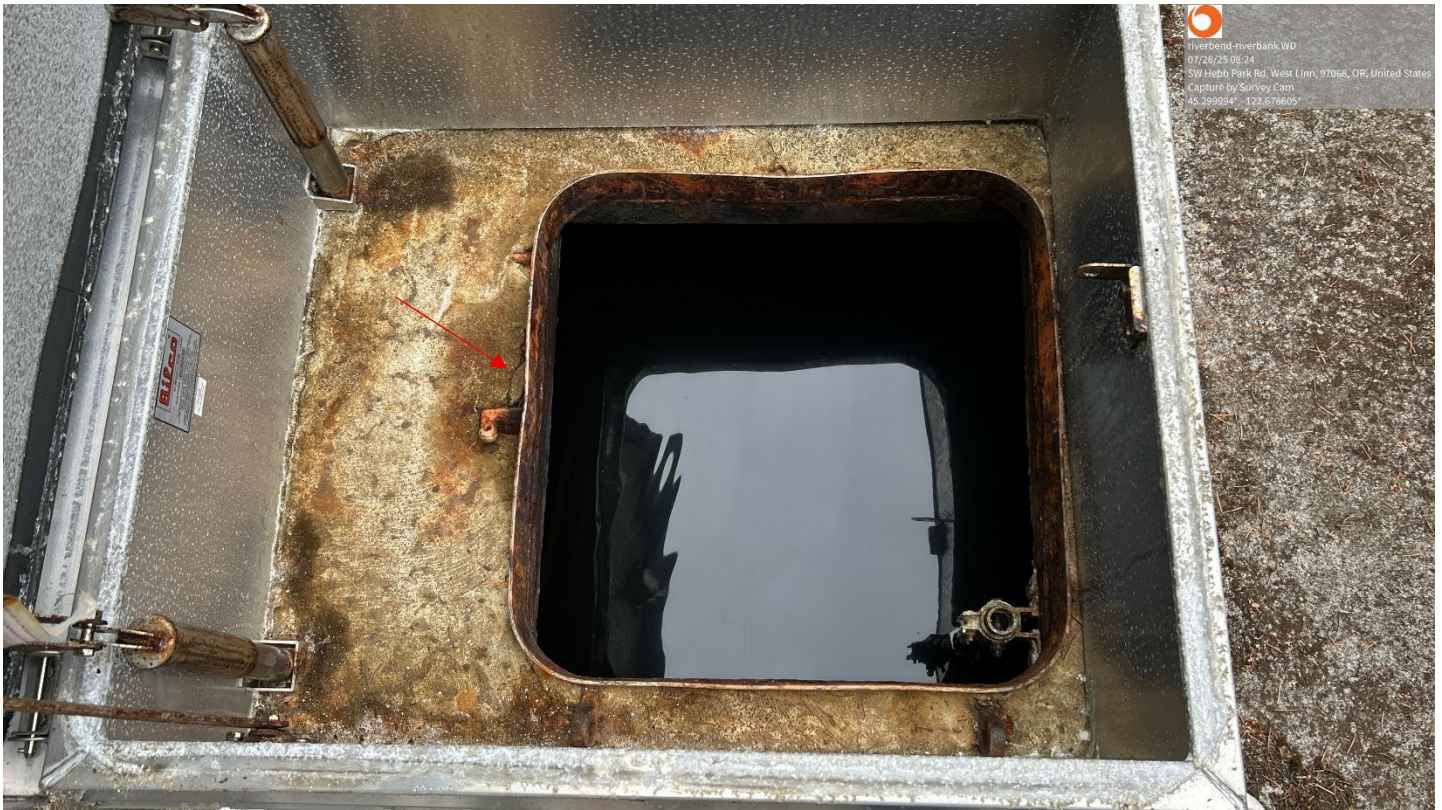
**Access Hatch – Settling Cracks & Corrosion Noted**

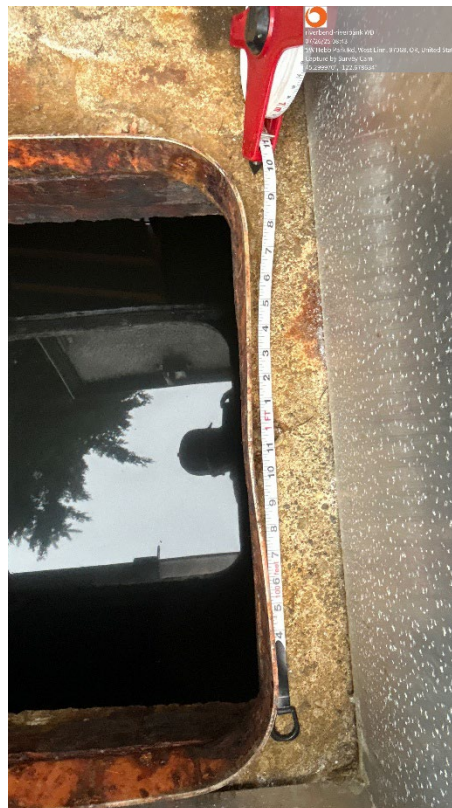
**Access Hatch – Corrosion Noted**

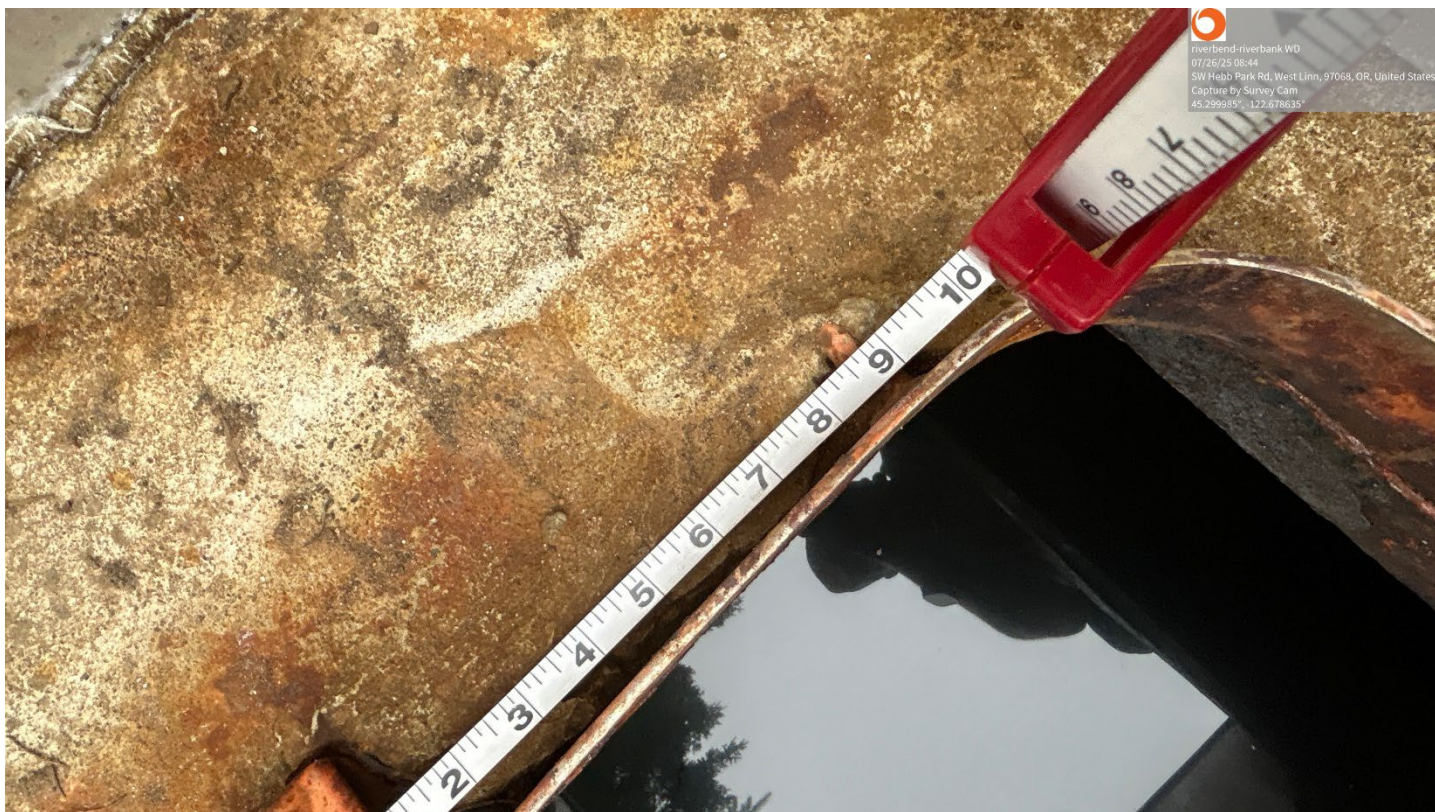
**Access Hatch – Corrosion Noted**

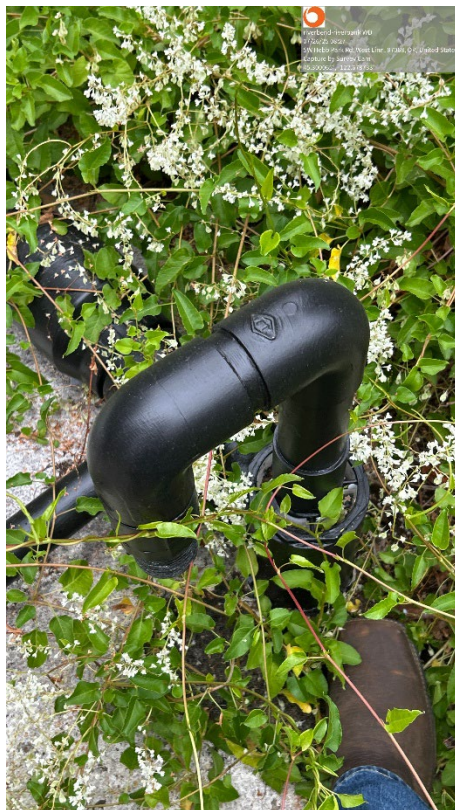
**Roof Vent – Biological Growth Noted**

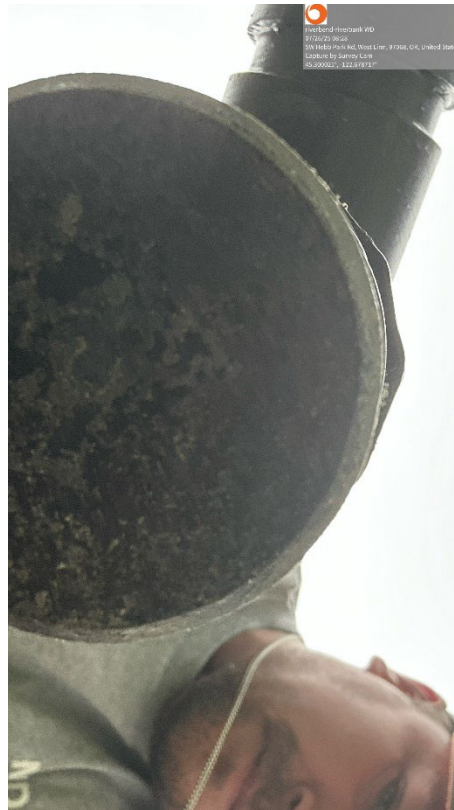
**Roof Vent Screen – Biological Growth Noted**

<input type="checkbox"/> Yes <input type="checkbox"/> No	Is the vent covered with #24 mesh corrosion resistant screening (some exceptions apply)? Mesh Size: <b>screen blockage noted</b>	If no, indicate deficiency and proposed correction: <b>Replace blocked roof vent screen.</b>		
<b>Buried or Partially Buried Tanks</b> <input checked="" type="checkbox"/> Check if NA				
<input type="checkbox"/> Yes <input type="checkbox"/> No	Is the vent covered with #24 mesh corrosion resistant screening?	If no, install proper #24 mesh corrosion resistant screening.		
<input type="checkbox"/> Yes <input type="checkbox"/> No	Does the air vent terminate downward?	If no, re-configure the vent so that it terminates downward.		
<input type="checkbox"/> Yes <input type="checkbox"/> No	Is the air vent at least 24" above the tank roof or ground surface (whichever is higher)? What is the height of the vent above the roof or ground surface?	If no, raise air vent to provide for an appropriate air gap.

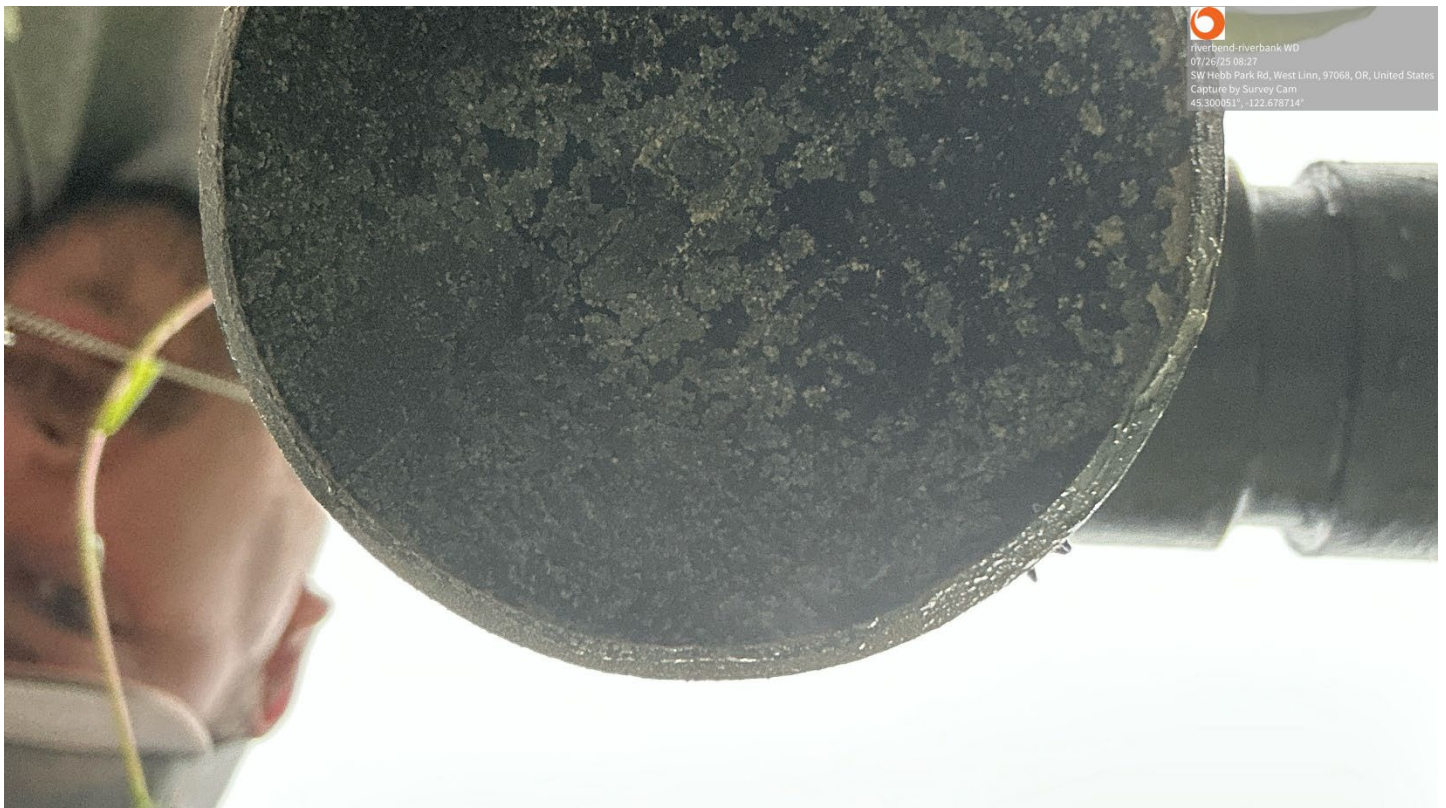
**Roof Vent Screen – Blockage Noted**

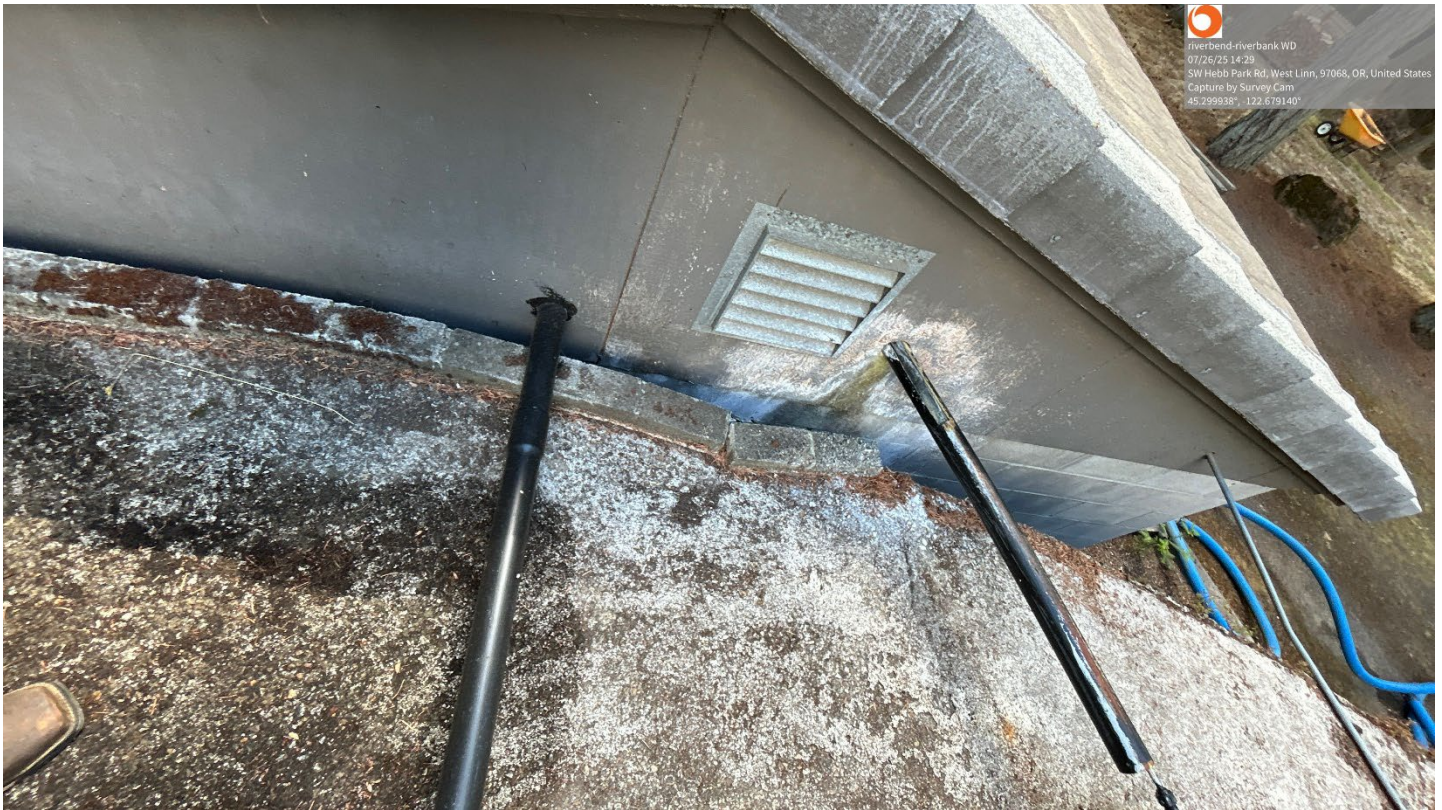
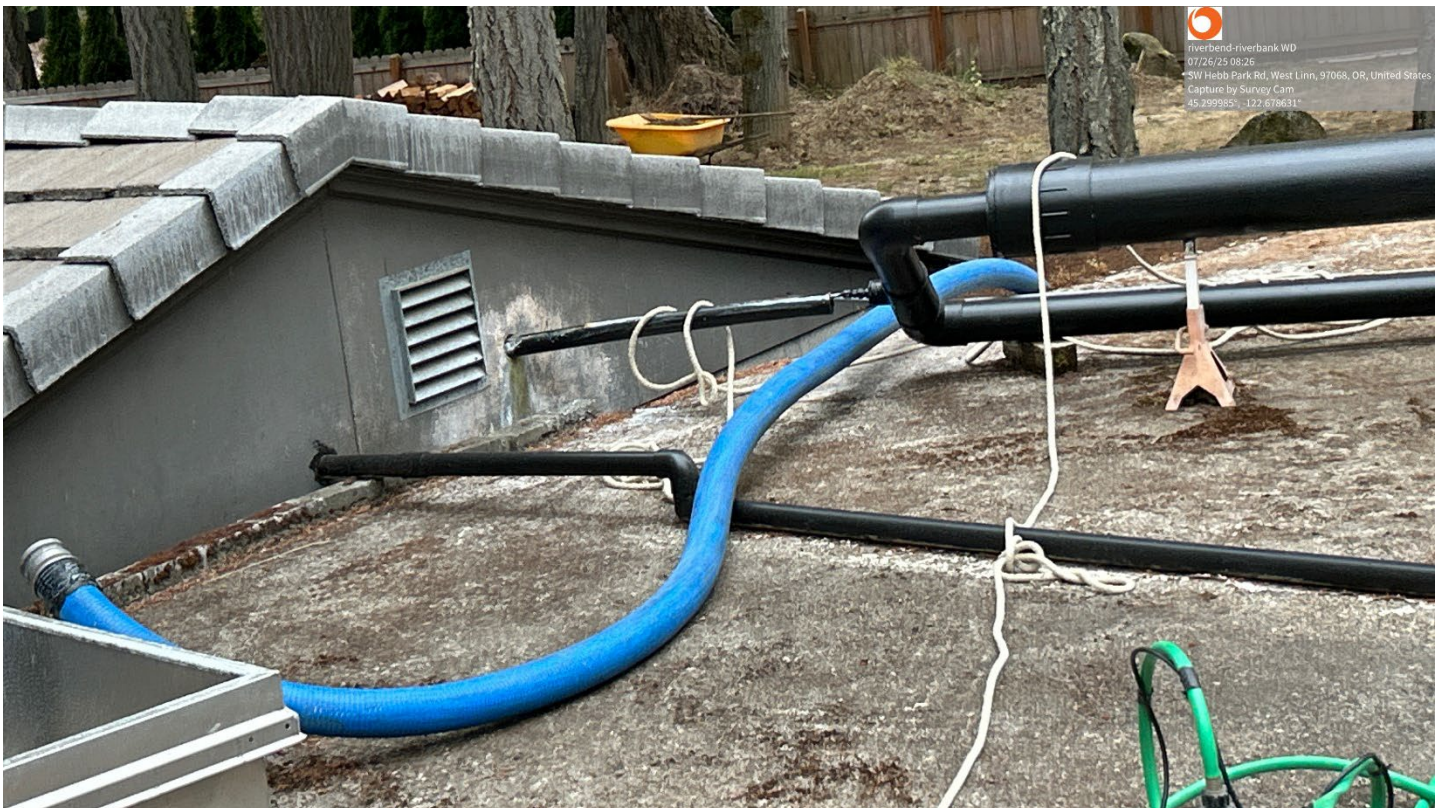
**Exterior Roof – Evidence of Water Migration Noted**

Overall Tank Condition				
	Significant Deficiency	Required Correction	Proposed Completion Date	Actual Completion Date
<input checked="" type="checkbox"/> Yes <input type="checkbox"/> No	Does the tank appear to be structurally sound?	If no, what repairs are suggested by the tank inspector?		
<input checked="" type="checkbox"/> Yes <input type="checkbox"/> No	Are there any unprotected openings in the tank (breaches, <b>leaks</b> , daylight coming through tank in spots, etc.)?	If yes, indicate type of breach and how it should be repaired: <b>Investigate &amp; repair evidence of water migration noted.</b>

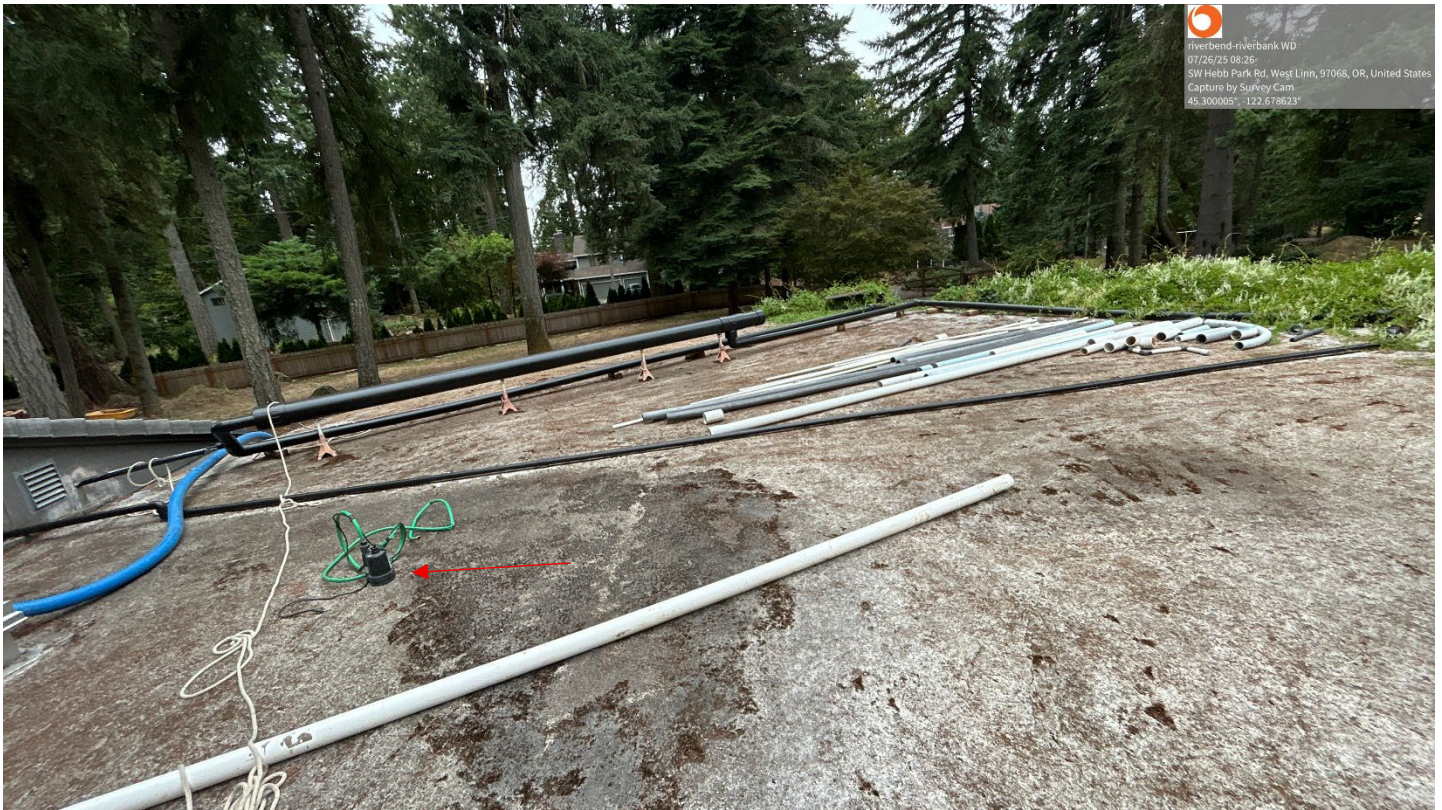
**Exterior Roof & Telemetry – Not Functioning**

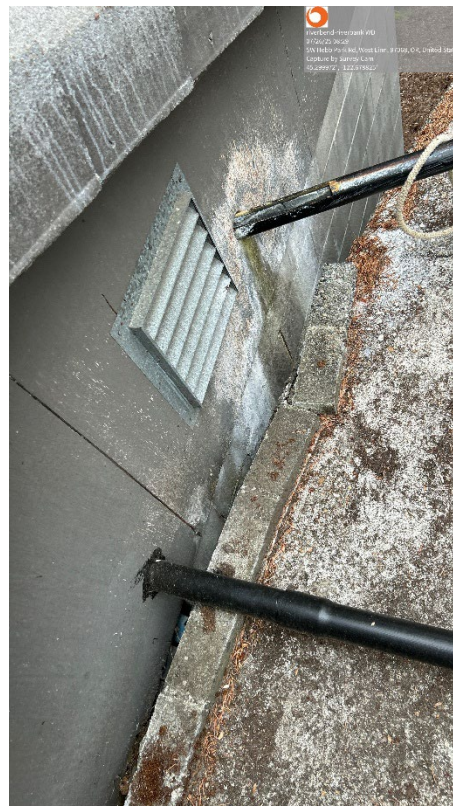
**Inlet Plumbing – Evidence of Water Migration Noted**

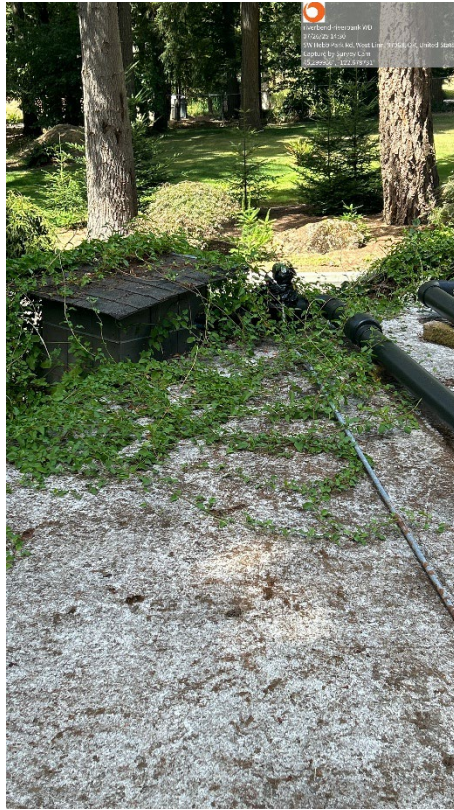
**Inlet Plumbing – Biological Growth Noted**

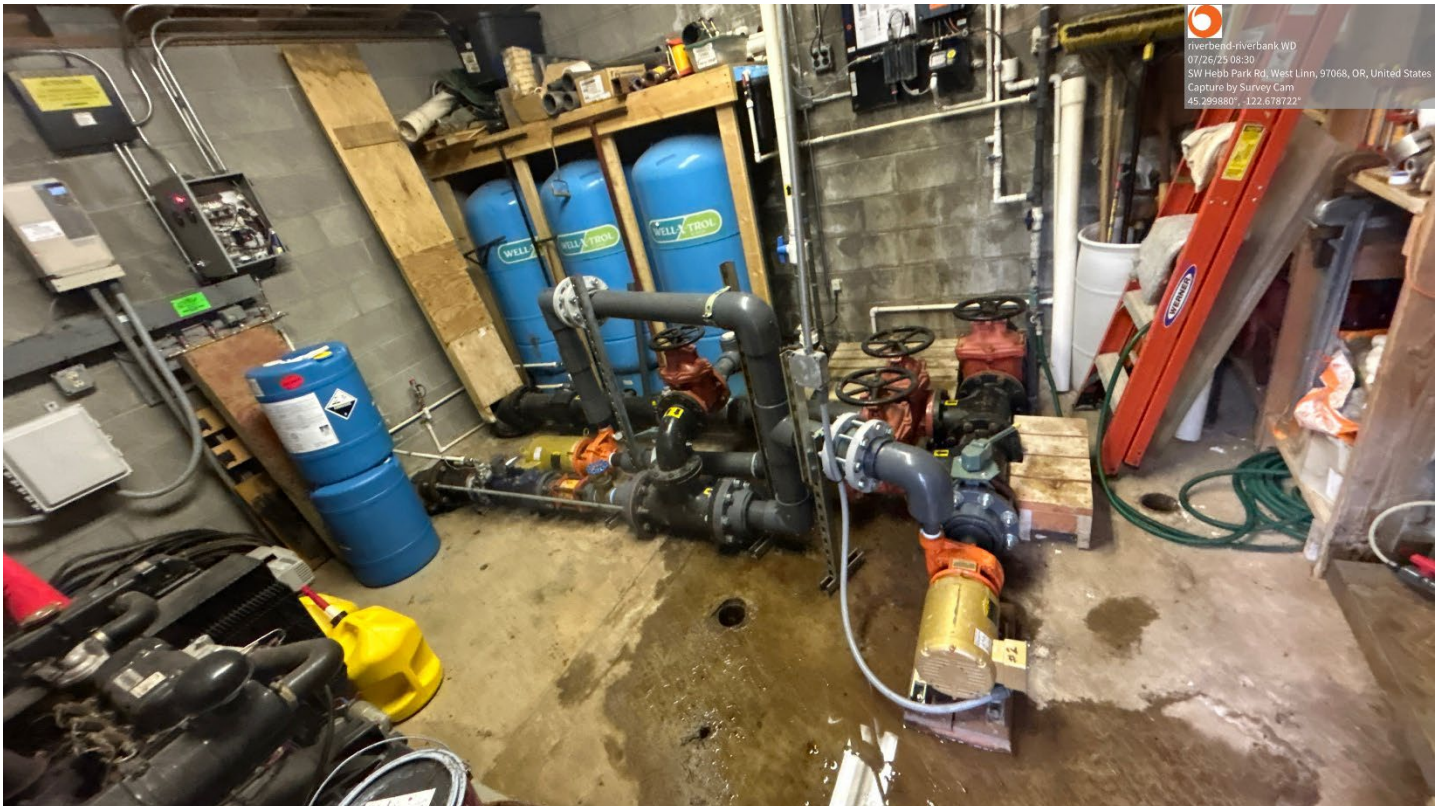
**Inlet Plumbing – Evidence of Water Migration Noted**

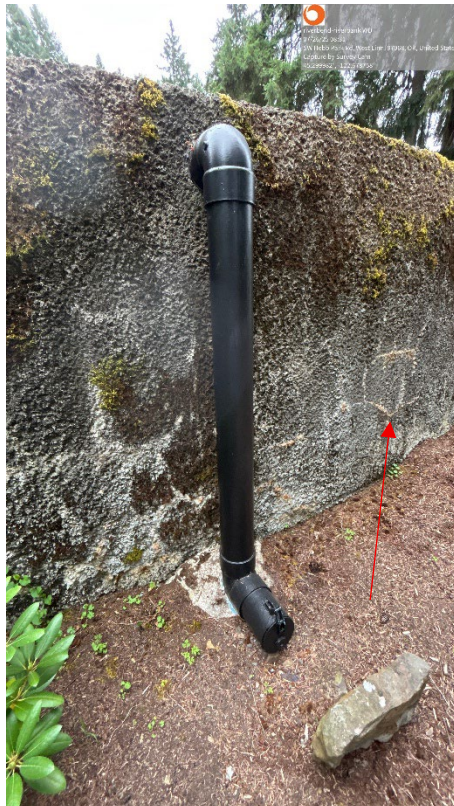
**Overflow Plumbing – Settling Cracks Noted**
