**Confidential Report of Procedures and Findings  
From the Cleaning & Inspection of the  
Primary Tank  
Riverbend-Riverbank Water District  
West Linn, OR**

**RE: 2025 Tank Maintenance Project**

The following is a summary of a visual and video inspection of the Primary Tank for Riverbend-Riverbank Water District in West Linn, OR. This inspection was undertaken on July 26, 2025 by Midco Diving & Marine Services, Inc., of Rapid City, SD. The findings of this inspection report are a supplement to the inspection video.

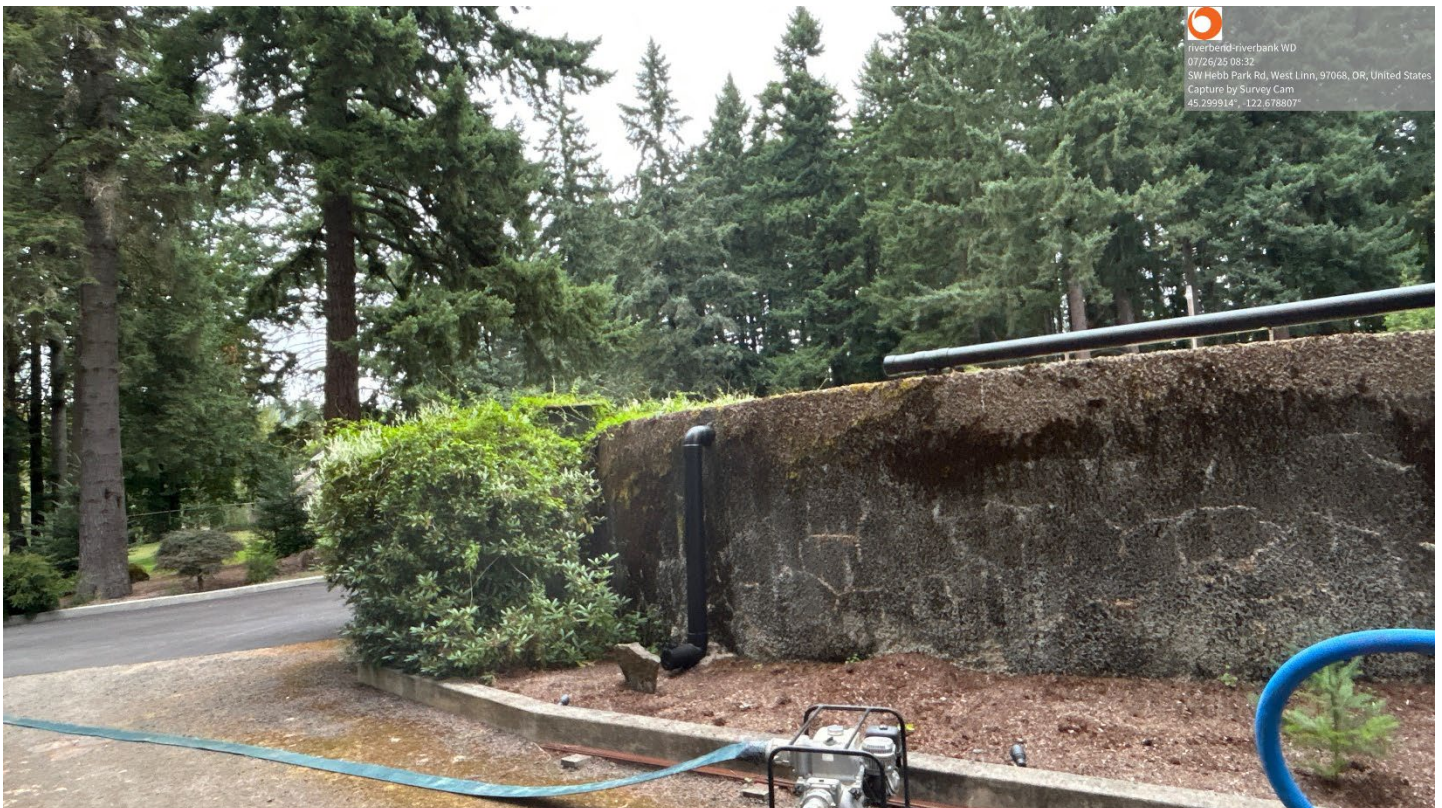
**Exterior Reservoir – Settling Cracks Noted**

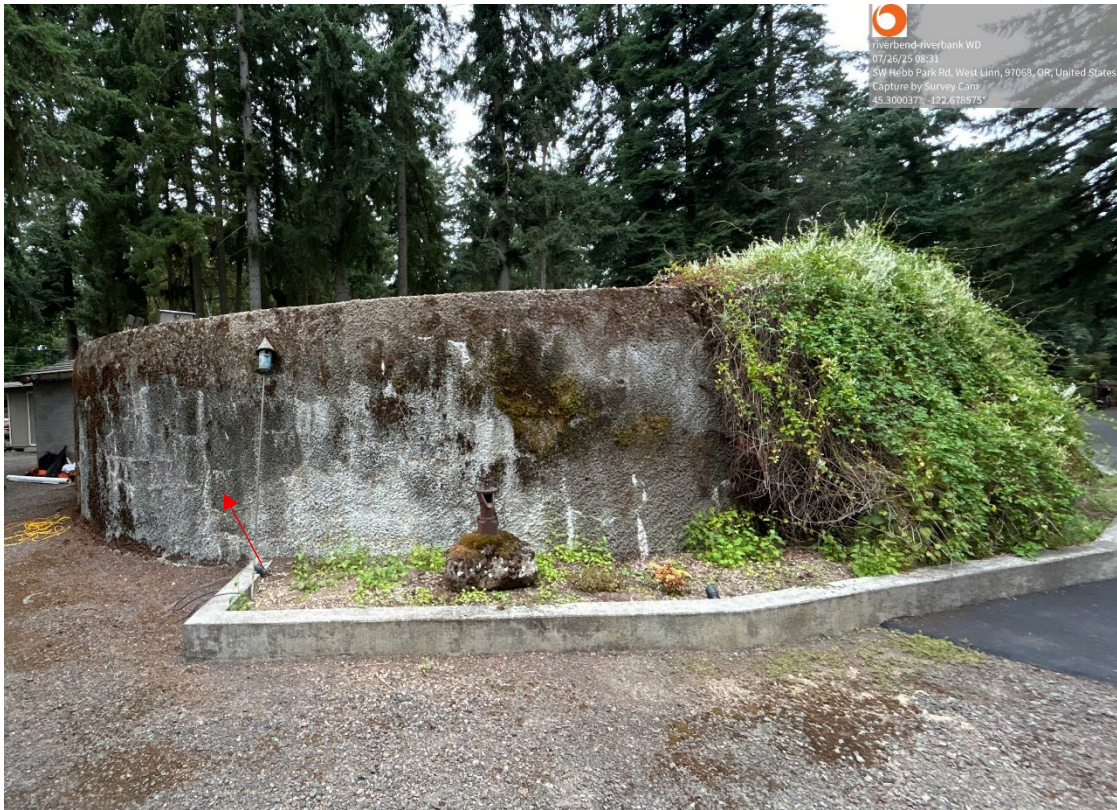
**Exterior Reservoir – Settling Cracks & Biological Growth Noted**
